TEST OF PRECAST PRESTRESSED  
ROOF PANEL NO. 3  
(Type B)

L. F. Skoda, J. O. Bryson and D. Watstein

Report to  
Bureau of Yards and Docks  
Department of the Navy

November 1, 1954

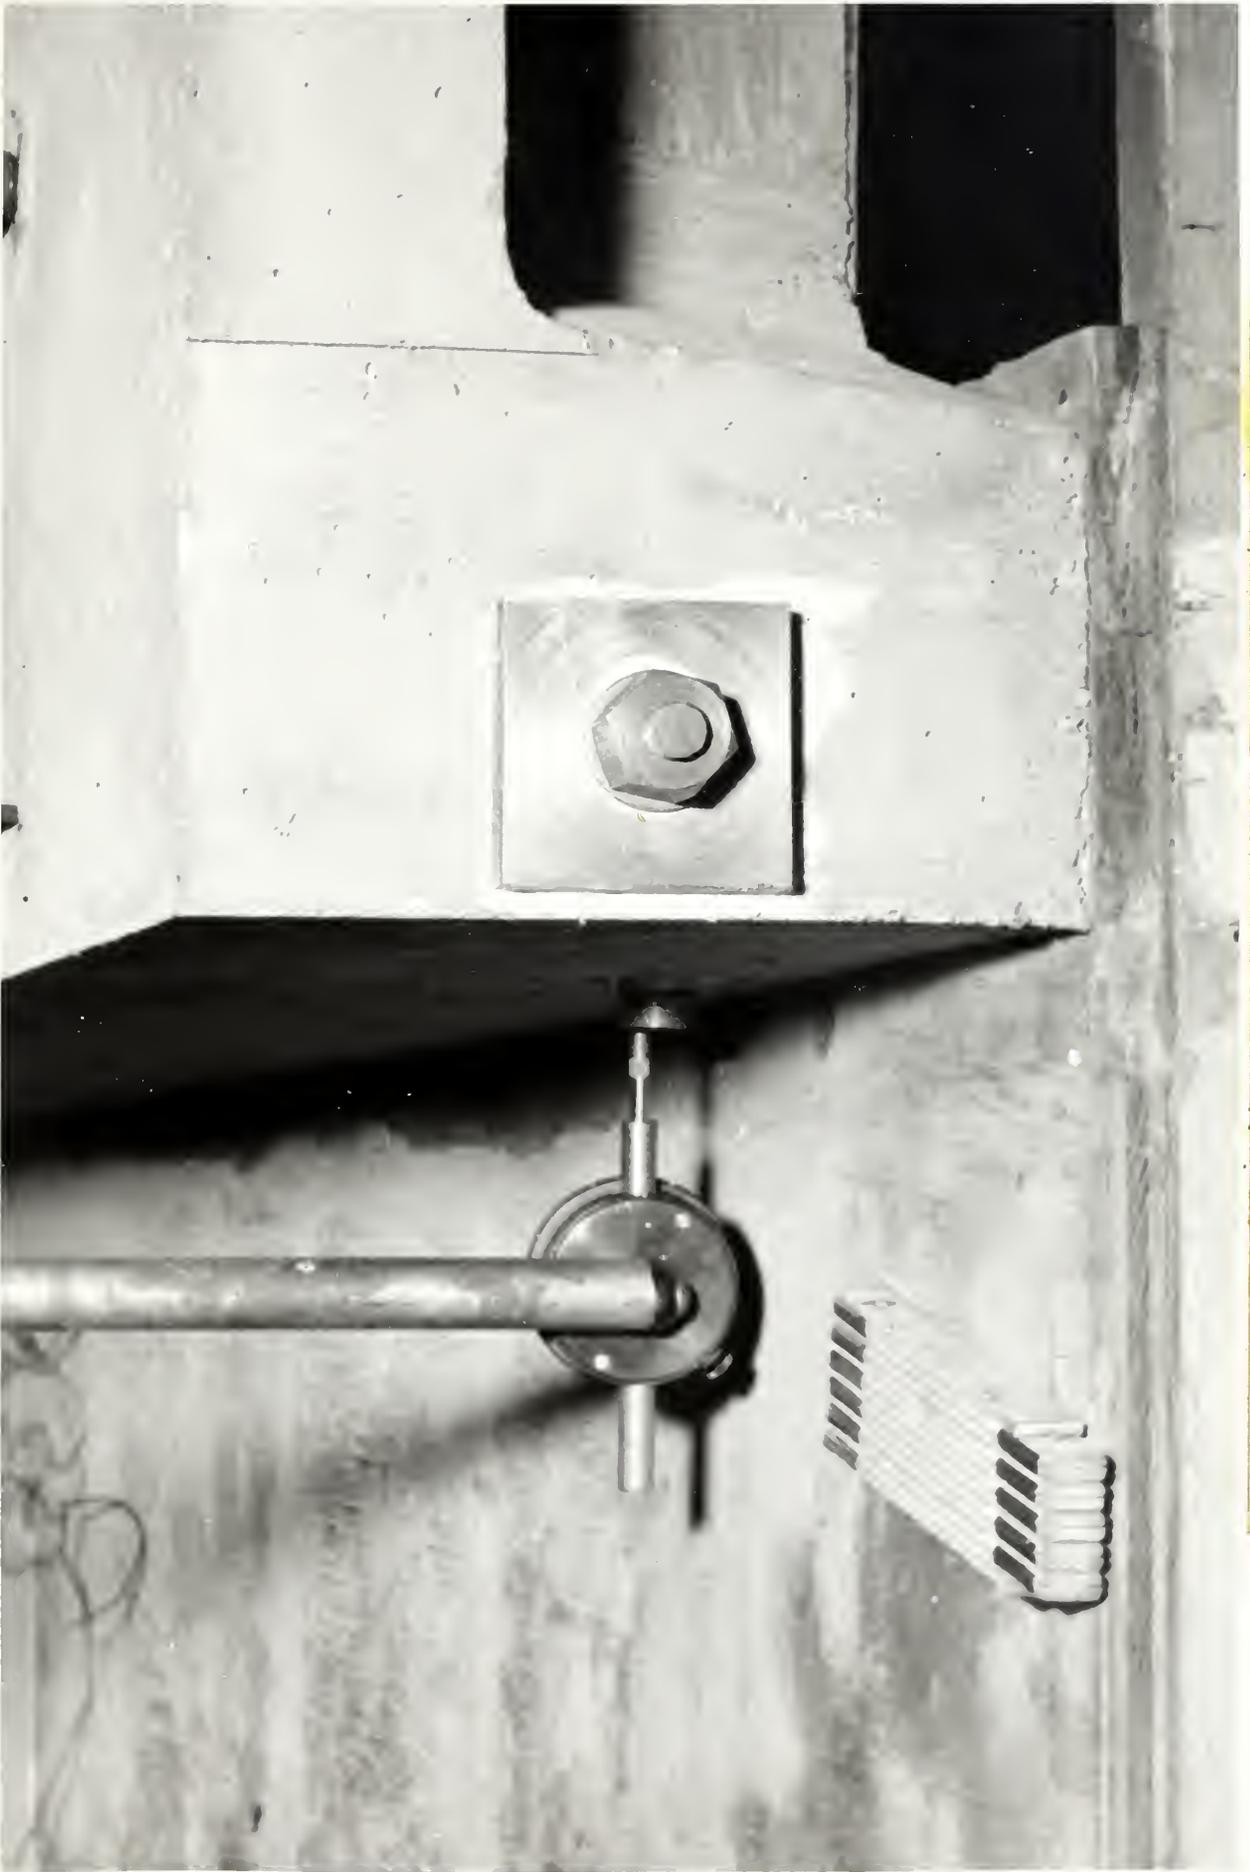
Fig. 2 - Close-up view of anchorage of prestressing bar.

Prestressing was applied to the specimen 21 days after the concrete was placed. First the Stressteel bars were slipped into their respective conduits which were cast in each longitudinal edge beam of the specimen. The bars were then anchored at the ends opposite to the jacking point, as shown in figure 2. Dynamometers were inserted at the jacking points between the bearing plates and the prestressing apparatus. The dynamometers were used to control the load applied to the specimen. A close up view of the dynamometers and prestressing apparatus in place for prestressing is shown in figures 3 and 4. The bars were stressed in both edge beams simultaneously until a load of 18,500 lb was obtained. The jacks were released and the load immediately dropped to 17,200 lb. Twelve days later, the load had dropped to 16,800 lb. The Stressteel bars were then tensioned to 19,500 lb and the tension dropped to 19,200 lb immediately after the release of the jacks. This tension was maintained within a reasonable tolerance up to the time of test.

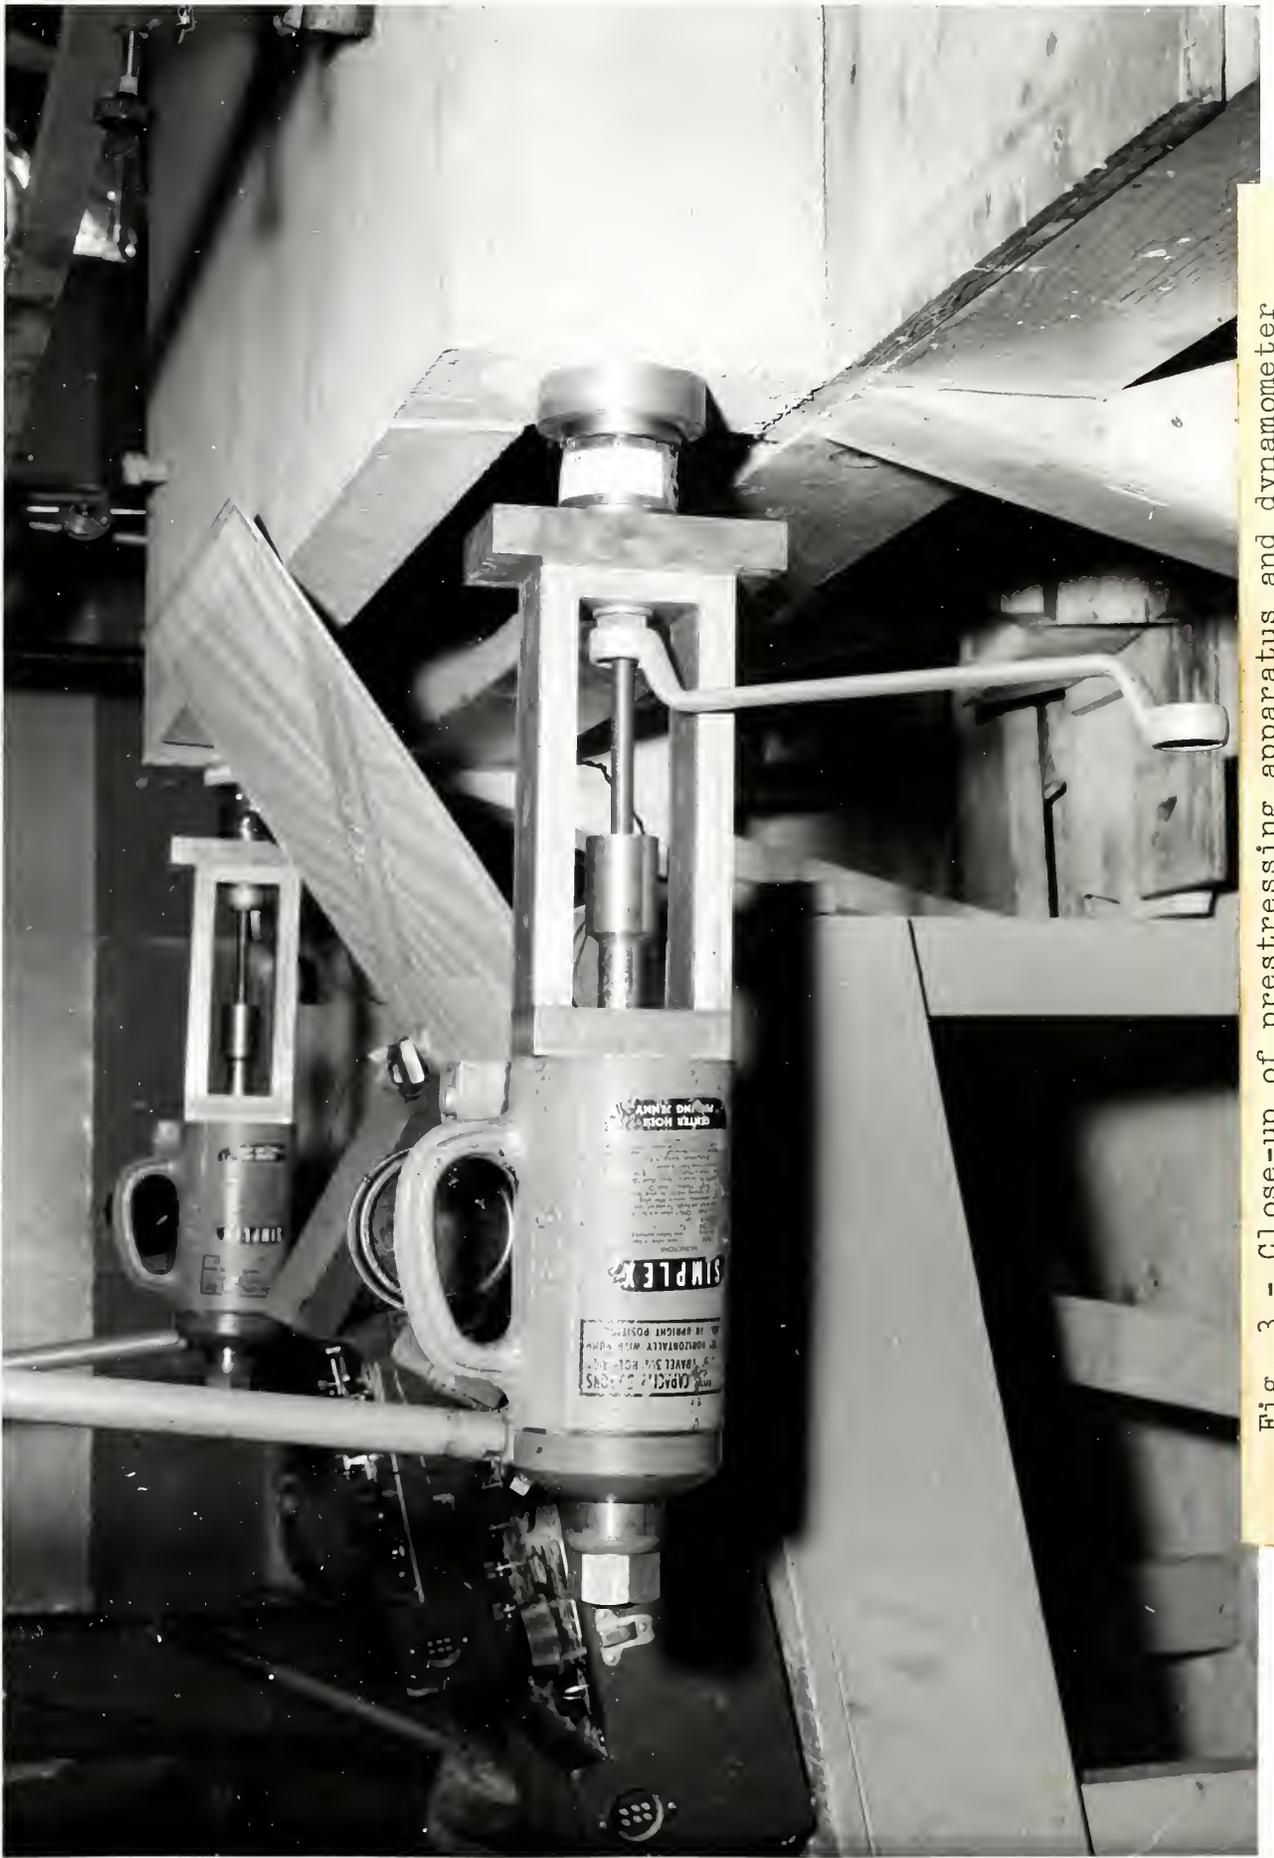
Fig. 3 - Close-up of prestressing apparatus and dynamometer in place.

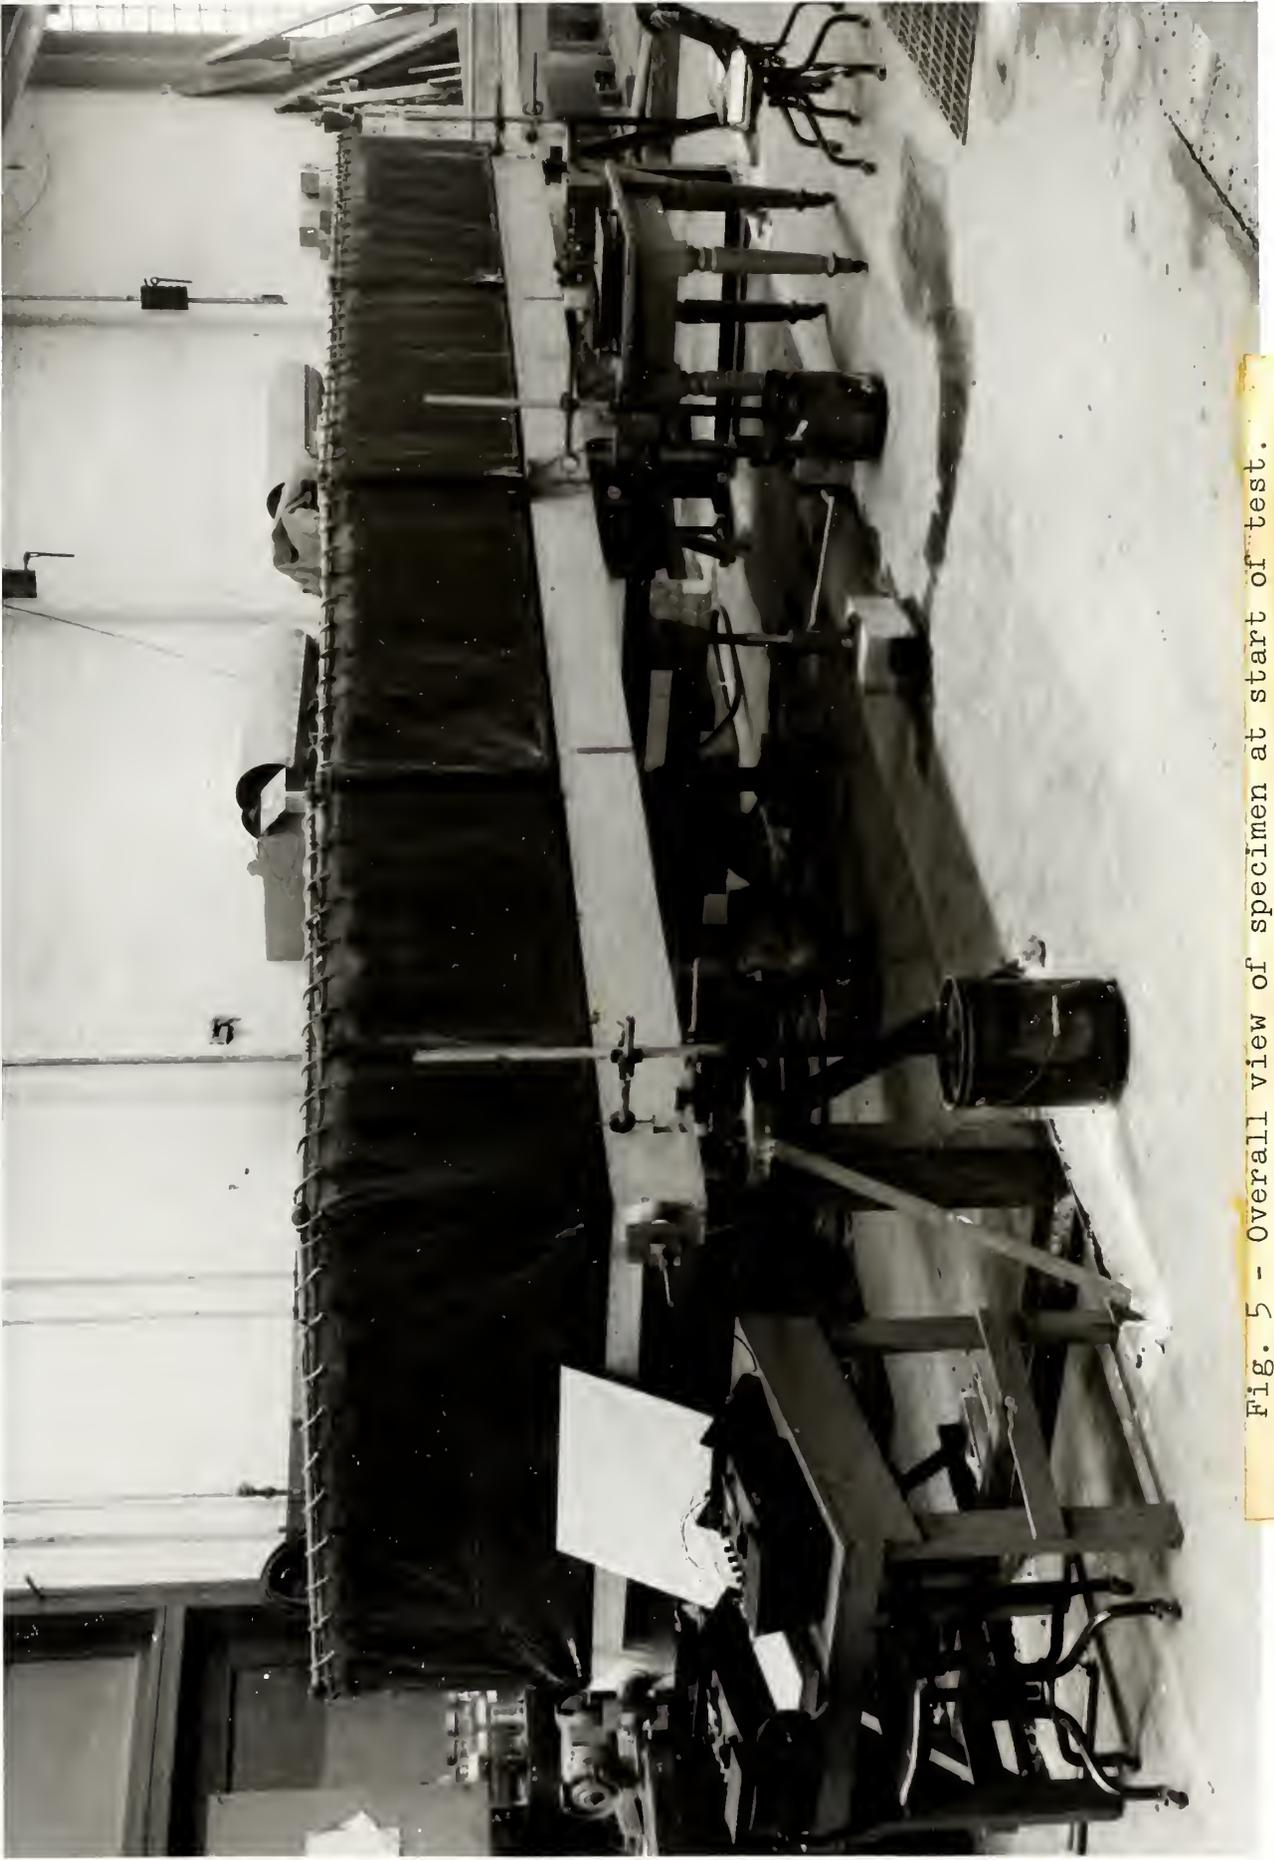
Fig. 5 - Overall view of specimen at start of test.

quantity of water entering the tanks was measured with individual water meters. Figure 5 shows the overall view of the test set up with the water tanks in place.

Deflections of the slab under load were measured with 0.001 in. micrometer dial gages and taut-wire mirror-scale devices. During the load test, the dial gages were located on the underside of the slab at the same points at which measurements were taken on the top of the slab during the prestressing. Four dial gages were placed across the center cross-section of the span and four were placed at both ends over the supports. Taut-wire mirror-scale gages were located on the outside of the edge beams of the center section and quarter point sections of the span. An overall view of the location of the gages is shown in figure 5.

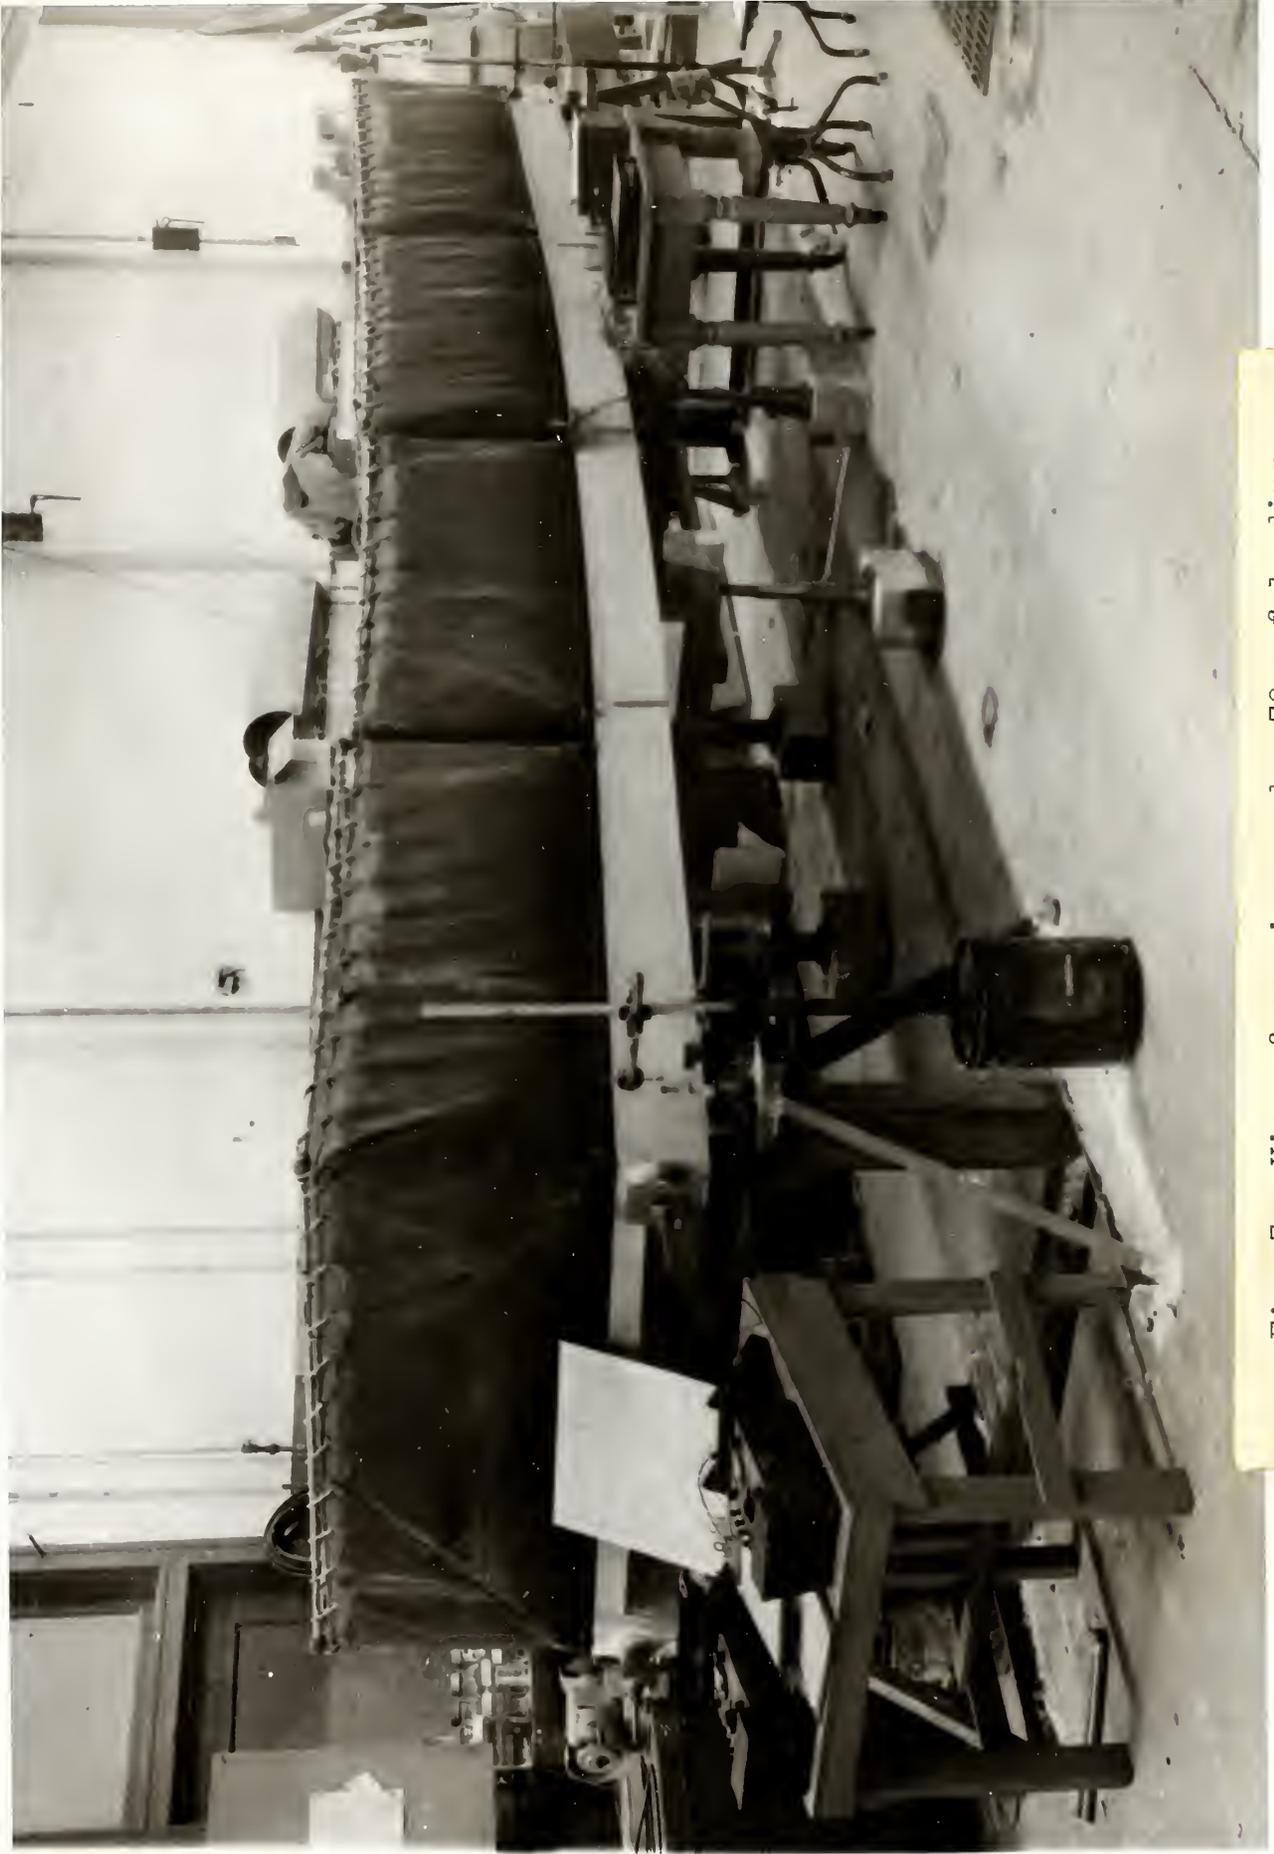
Fig. 7 - View of specimen under 70 psf loading.

The specimen was loaded in increments of 10 lb/sq ft and readings of all gages were recorded after each loading. The first noted crack occurred in the center section of the east edge beam at 50 lb/sq ft. The specimen was loaded to 70 lb/sq ft and that load was maintained for 1 1/2 hr at which time an additional set of readings of the gages was recorded. (See figure 7). The load was then removed from the specimen by siphoning the water from the tanks. The center section of the specimen recovered to within 0.2 in. of its original position and the tensile cracks closed up. Figure 9 shows the same crack as figure 8 with the load removed. The next day, the specimen was reloaded and additional measurements were recorded.

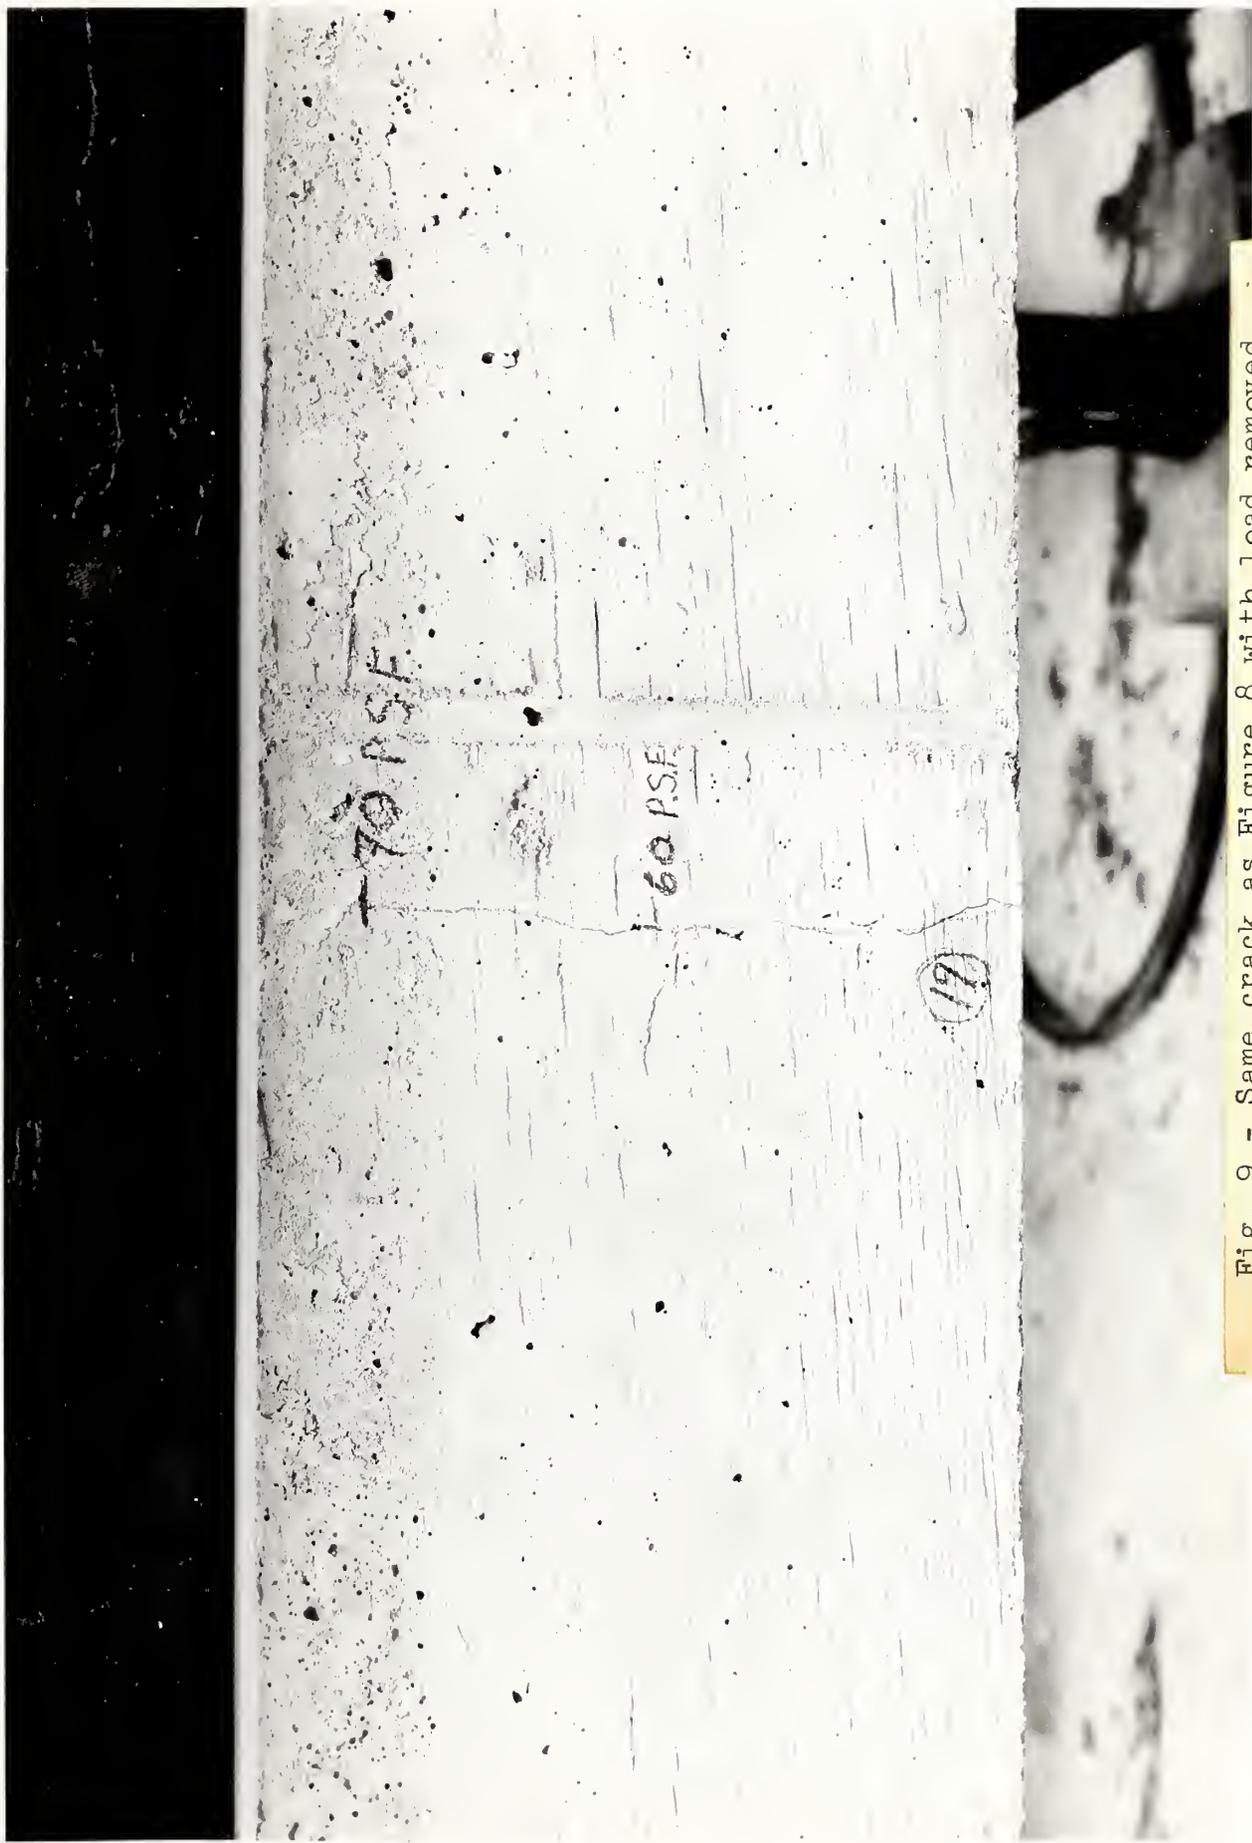
Fig. 9 - Same crack as Figure 8 with load removed.

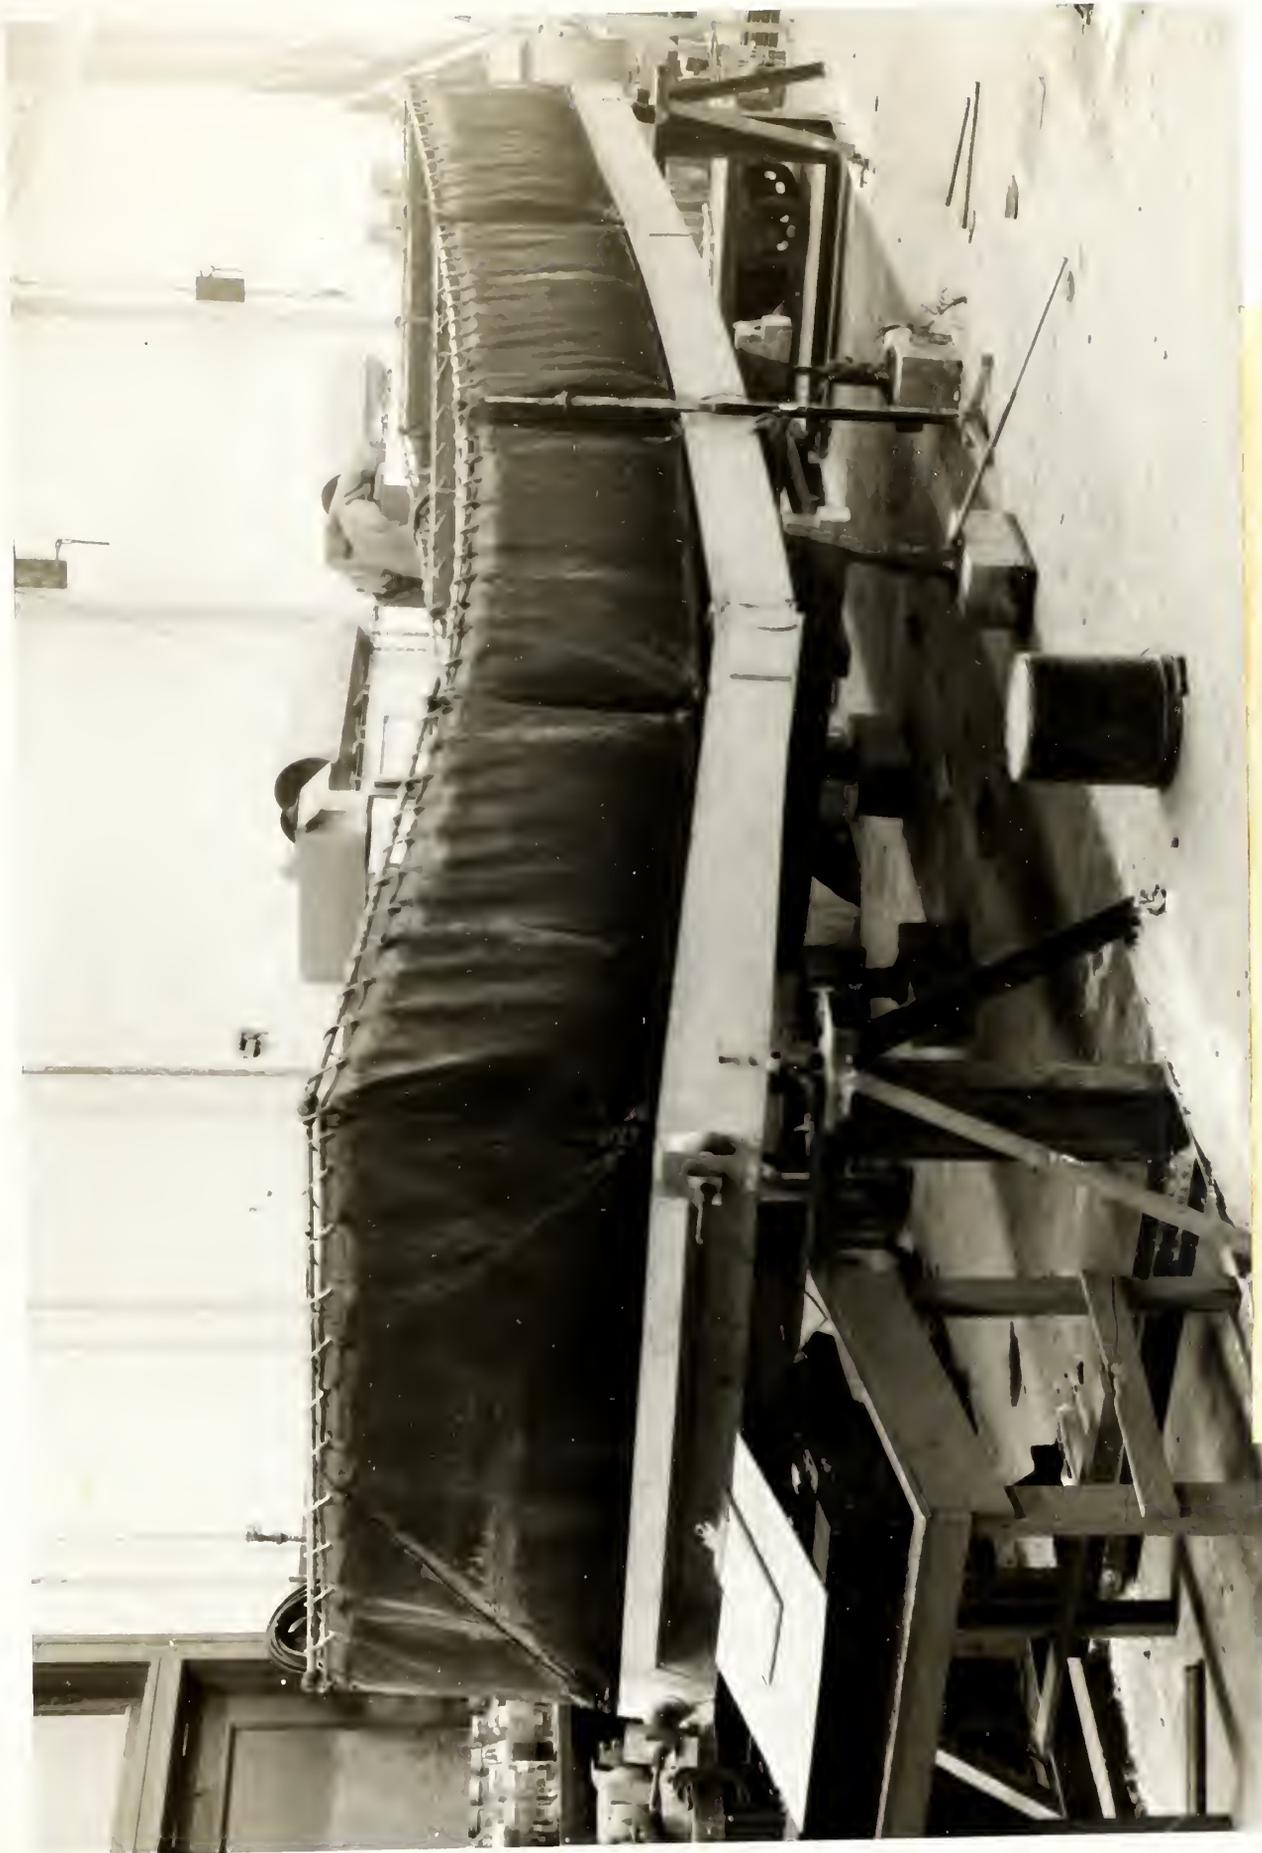
Fig. 20 - Overall view showing failure at 80 psf.

The primary cause of failure was yielding of the longitudinal reinforcement accompanied by compressive failure at the top of the edge beams and the adjacent portion of the slab. The view of the panel at failure is shown in figure 20 and a close-up of the edge beam is shown in figure 21. The same section of the edge beam after the load was removed is shown in figure 22. It can be seen that fracture occurred in the welded wire reinforcement at that section. An overall view of the specimen after removal of the load is shown in figure 23. The maximum observed deflection of the panel at

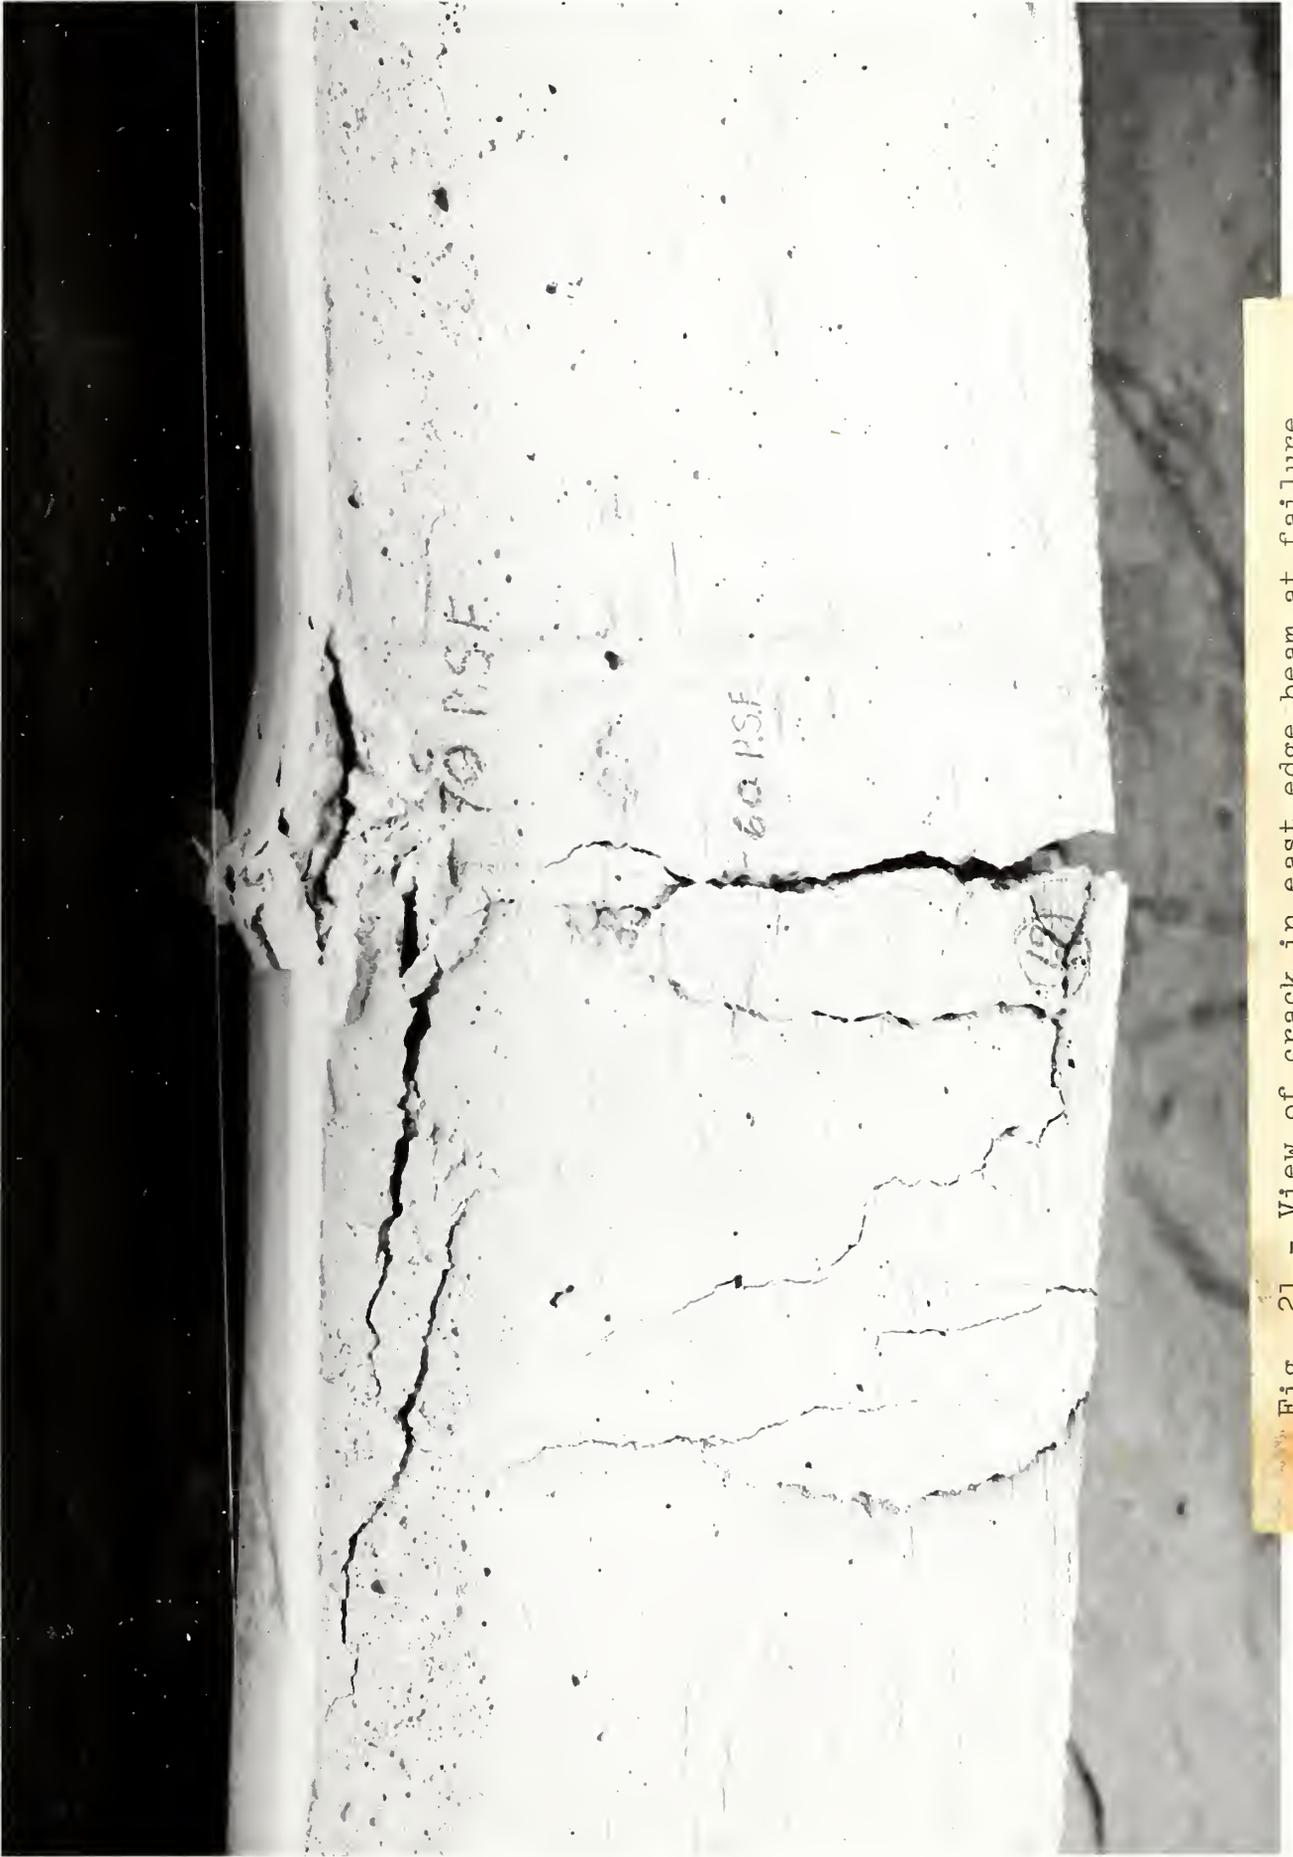
Fig. 21 - View of crack in east edge beam at failure.  
(Load = 80 psf).

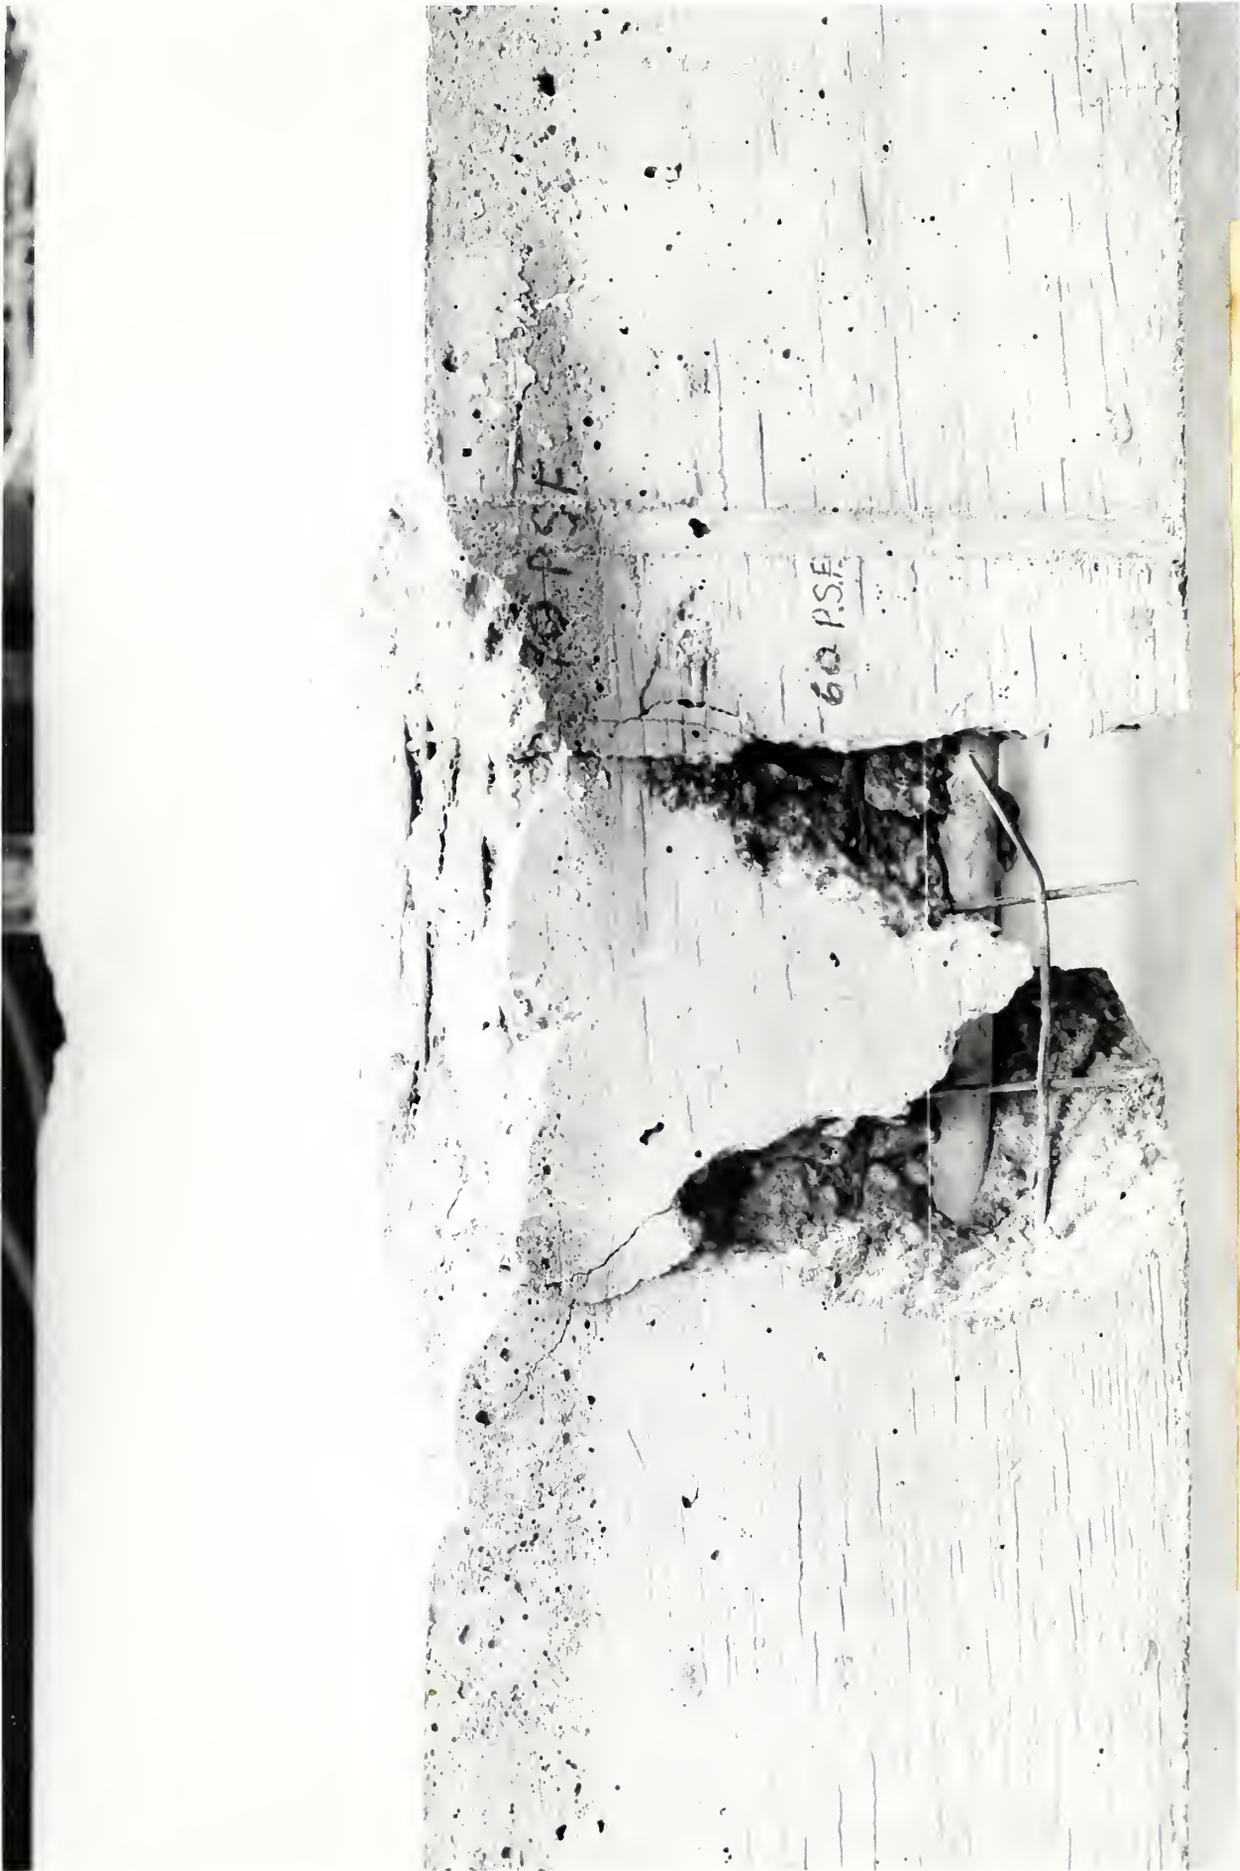
Fig. 22 - View of crack in east edge beam after removal of load.
